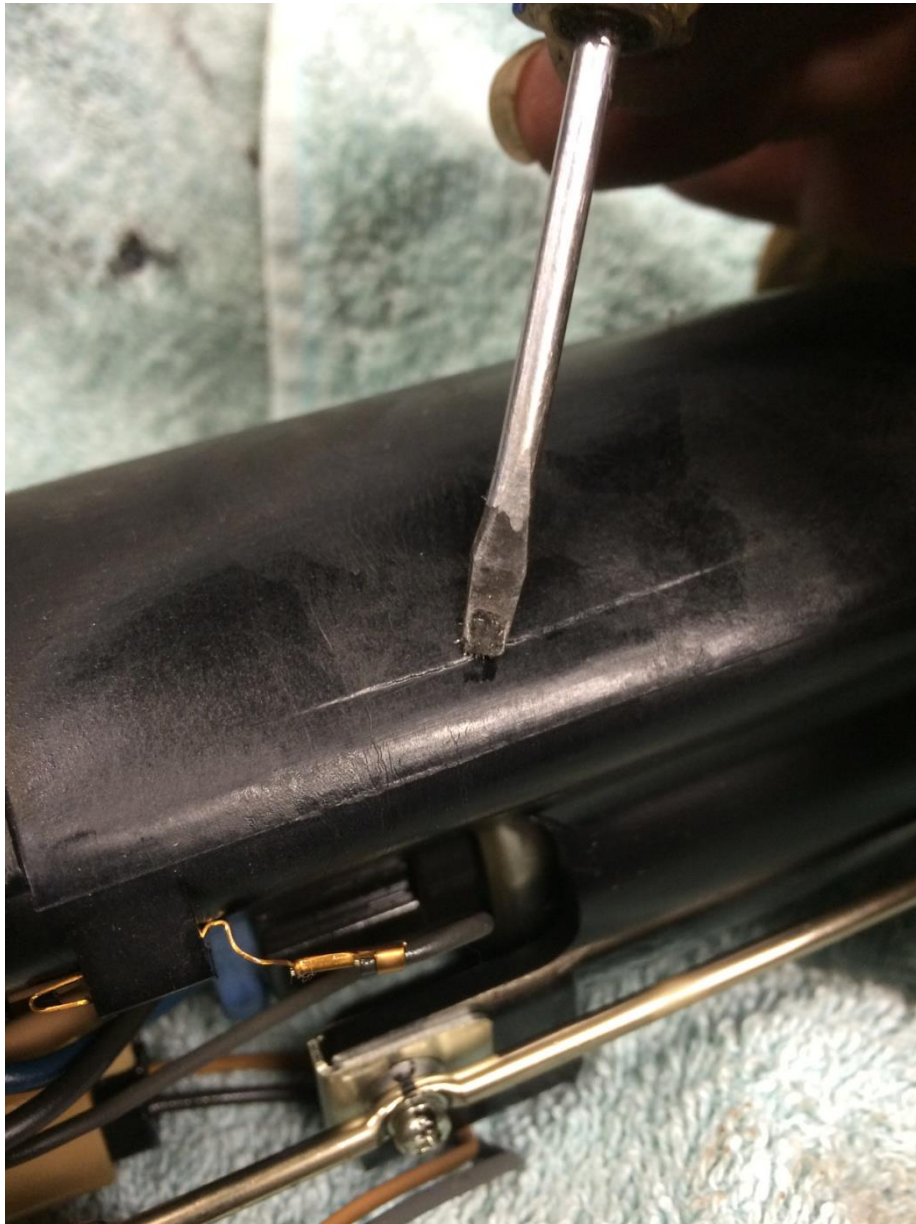
Follow the screwdriver; you see a wet spot at the base

Note the notorious crease in the plastic moulding

The actual crack is only about 3mm, but will follow the crease over due time

This is purely a plastic injection defect.
